Construction Supervision of a Zinc Tailings Storage Facility and Return Water Dam

A. van der Westhuizen

Abstract

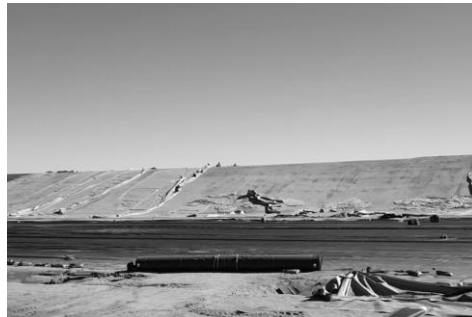
Figure 8. Newly opened (cut) starter wall

- There were some instances where the crest of the starter wall's geomembrane was lifted due to wind uplift. Many square meters of geotextile moved from its original position underneath the double textured geomembrane. This was mended by cutting open the geomembrane, re-placing the geotextile, tack welding the outer edges of the adjacent geotextile panels together and then welding the geomembrane panels. Sand bags were placed in the anchor trench at the top of the starter wall to combat the wind uplift further. The problem and solution can be seen in Figure 8 and Figure 9.

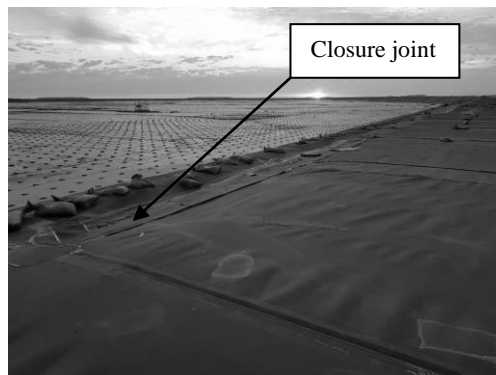
Figure 10. Crest on the starter wall being ballasted with sand bags

- Shallow calcrete nodules were ripped up with the in-situ basin material which caused many surface preparation difficulties;
- A very time consuming and costly exercise to prepare the basin to an acceptable finish; and
- Wind uplift and ingress created wrinkles in the geomembrane. During the lining process, many of the geomembranes leading edges were not connected to another fixed (drain) piece of geomembrane. This resulted in wind ingress and uplift over the geomembrane which caused excessive wrinkles in localized areas.

- Due to the aforementioned problem, all rip and re-compaction activities were stopped;
- Areas that were rip and re-compacted, were compacted by means of various passes of the pad foot roller, smooth drum roller and pneumatic roller with a layer of screened sand placed afterwards;
- Moving forward the surface to be lined, was only wetted and rolled various times with the vibratory smooth drum roller to acquire the specified compaction. After this, screened sand was placed to be wetted and rolled by the pneumatic roller to achieve the required surface finish;
- In both areas, an assigned work force walked the surface during and after prep work to remove rocks that did not meet the specification; and
- The wrinkles created were cut and pulled out. Sand bags were placed in a pattern to combat this from happening further as can be seen in Figure 10 below.
