Grouting to reduce seepage at Neckartal Dam, Namibia

R. Greyling, E. Lillie, D. Mouton

Knight Piésold Consulting, Pretoria, South Africa

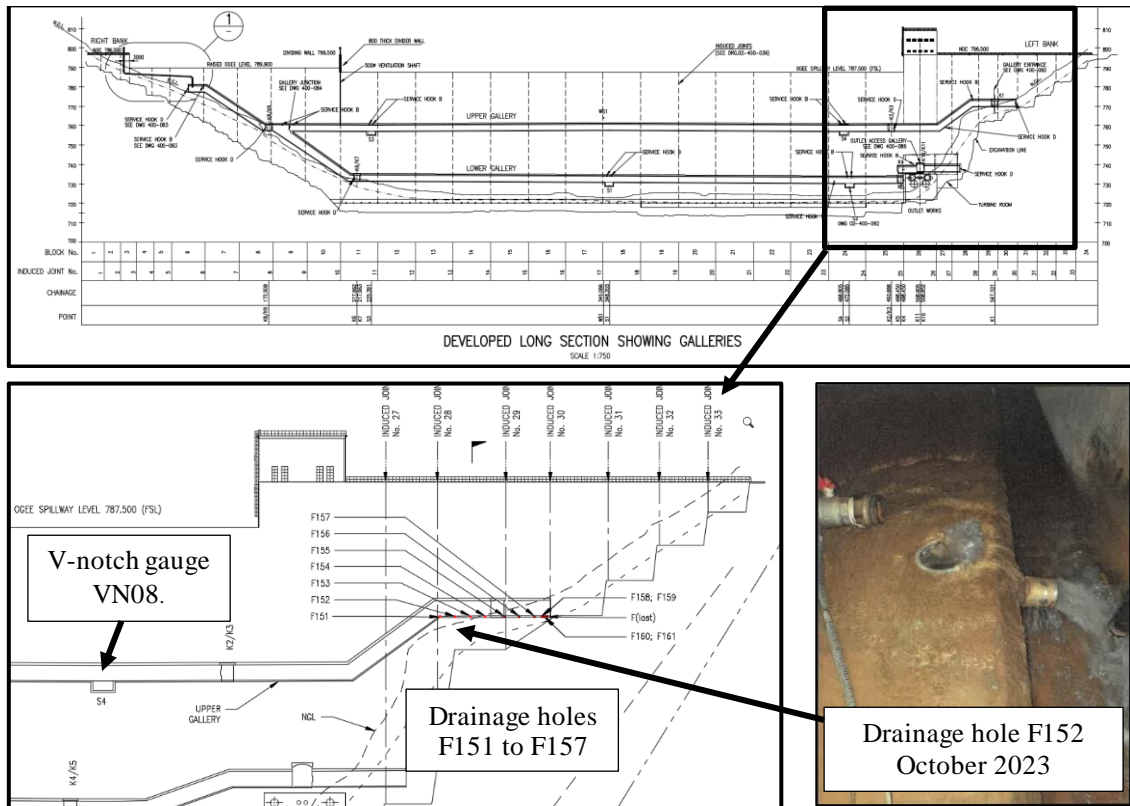
Following closure, Neckartal Dam filled rapidly during the 2020 to 2021 wet season and spilled for the first time in January 2021. Seepage from the dam is monitored at eight v-notch gauges (VN001 to VN008) located inside the dam's drainage galleries. As the dam filled to the Full Supply Level (FSL), an increase in seepage was recorded, which was expected. Seepage rates were within the stipulated acceptable limits and were observed to remain constant or decreasing until May 2021, when a sudden increase in measured seepage flows was observed at VN 008, installed in the upper left bank gallery. Measured seepage steadily increased from 3 ℓ/s to 12 ℓ/s over a 4-month period at this gauge before stabilizing at the end of 2021. The seepage rate peaked at an unacceptable level of 12.80 ℓ/s in August 2022. High seepage rates of over 10 ℓ/s are above the trigger limits set in the Neckartal Dam O&M manual, which require "action to be taken".- The seepage was observed predominately from a single drainage hole (F152 indicated in Figure 2) in the left upper drainage gallery.

Figure 2. Location of drainage holes in the left bank (seepage mainly from drainage hole F152).

F152: This drainage hole was tested first, and it was found that the depth at which water enters the hole occurs between 8.0 m and 8.2 m below the gallery floor level. It is possible that some water also enters the hole at depths below 8.2 m, but based on the visual observation of the flow rate, it appears most of the flow originated from this depth. Based on the as-built drawings, this depth corresponds to approximately the foundation interface. However, considering the effect of the steep foundation slope, it is difficult to determine the exact foundation contact level. It was therefore, concluded that the seepage was either from the foundation contact or the rock mass just below the foundation contact.

F151: The packer was lowered to a depth of 22 m in 1 m increments without managing to seal the inflow of water. The water flow was however sealed with a packer at a shallow depth of less than 1 m. This confirmed that the source of the flow in F151 was from below the gallery floor

slab. It was concluded that the source of flow in F151 was from F152, which pushed water underneath the gallery floor slab towards F151.

F153: The depth at which water enters the hole occurs between 10.0 m and 10.5 m below the gallery floor level. Based on the available information, this depth corresponds to a depth of approximately 2.5 m below the foundation contact into the abutment.

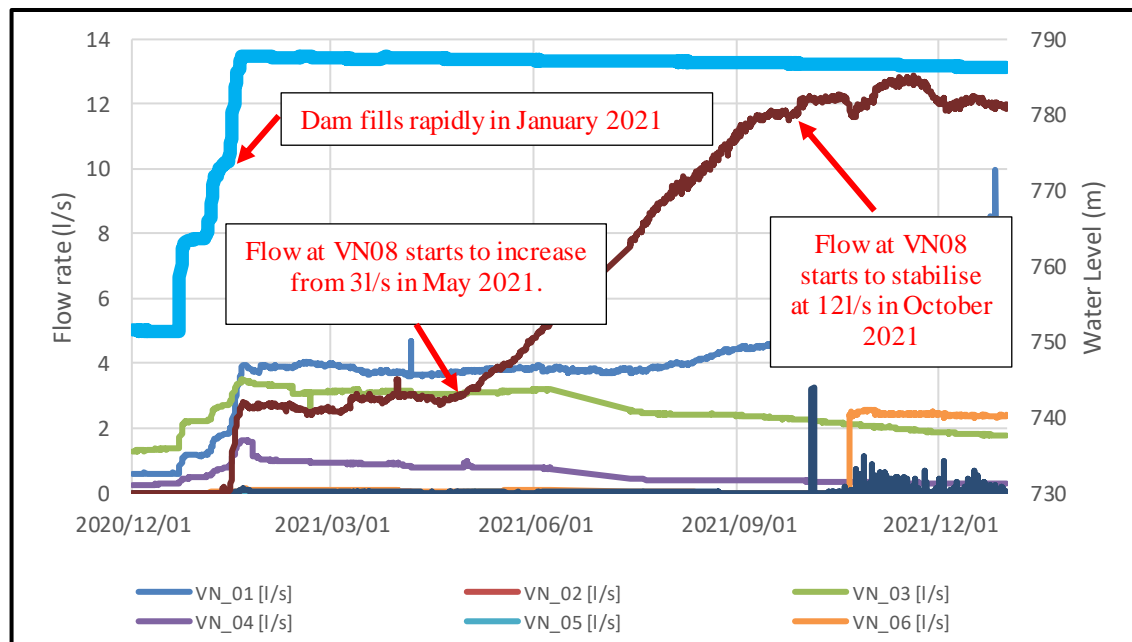
Figure 3. V-notch gauge flow rate and water levels from December 2020 to December 2021

However, measured seepage at VN008 increased rapidly at the beginning of May 2021, four months after first filling and continued to increase until October 2021. This increase in seepage was of concern as, at the time, it was not known whether it would continue to rise, stabilize or again reduce. Seepage from the adjacent gauges had remained relatively constant over that period. Seepage trends were closely monitored and found to stabilize by October 2021 but remained above the acceptable limit. Figure 3 indicates the dam water levels during the first filling and the seepage measured at each v-notch weir. Because the increase in seepage was recorded in May and the stabilization occurred in October, coinciding with the arrival of the colder and hotter seasons, respectively, it was assumed that differential temperatures of the concrete and foundation may influence the observed seepage rates.

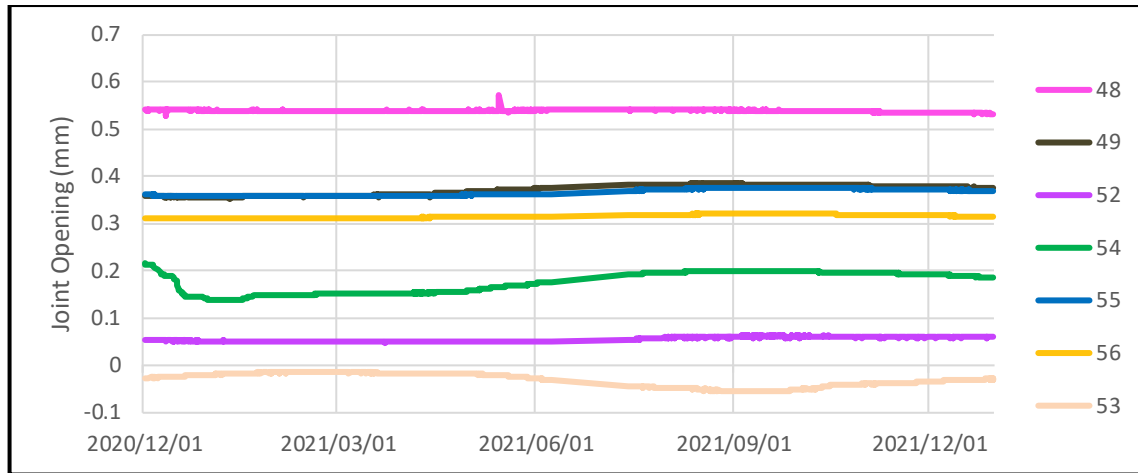
The LBSG indicated no opening or closing during 2021 except for joint 54, which opened by less than 0.1 mm during the first filling in January 2021. From the joints being monitored, no joint showed any significant movement, which could explain the seepage at VN008 increasing steadily between May and October 2021. The movements across joints #18 to #27 at LBSGs #45 to #50, #52, #54, #55 and #56 are shown in Figure 6 below.

Figure 6. Neckartal Dam: LBSGs at elevation 757m – Joint opening

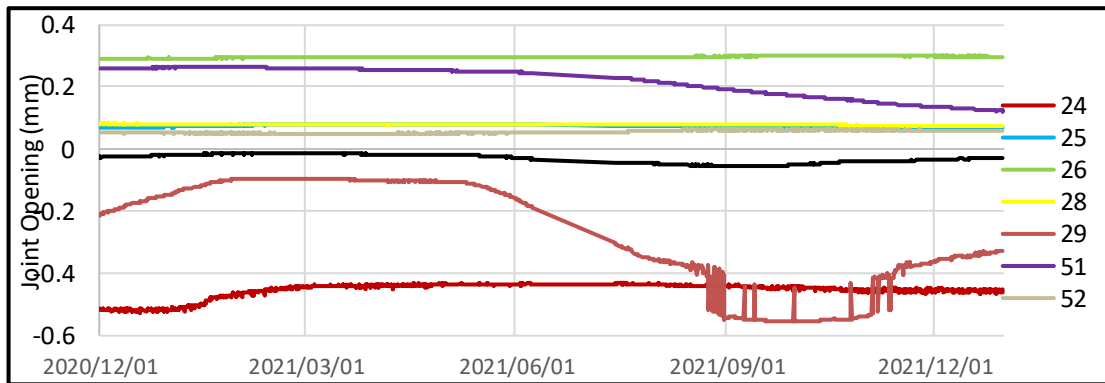
The only two LBSG to show a significant movement during 2021 were the two gauges close to the dam's downstream face. LBSG #29 indicated an opening of approximately 0.3 mm, and LBSG #53 indicated an opening of approximately 0.15 mm. Thus, the only opening of joint #24 was on the dam's downstream face. Neckartal Dam is northwest-facing; therefore, the downstream face is exposed to significant warming from the sun. The movements across joint #24 at LBSGs #24 to #29 and #51 to #53 are shown in Figure 9 below.

Figure 9. Neckartal Dam: LBSGs across joint 24 at elevations 730mASL & 757mASL -Temperatures

The opening of the downstream joint at LBSG #29 & #51 is consistent with the period of increased flow rates from May to October 2021.

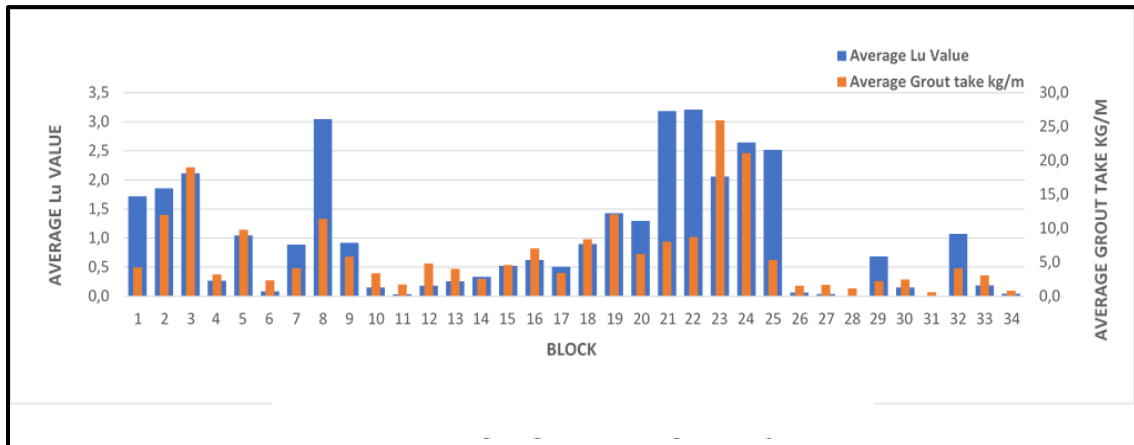
The average lugeon (Lu) value for the grout holes across the left flank is generally less than 2 Lu, with isolated zones of high permeabilities recorded in the first 10 m of S75 and P72, with Lu values of 6,9 Lu and 8,9 Lu respectively. The corresponding grout takes for S75 and P72 were 408 litres and 240 litres, respectively. These were the highest grout takes recorded along the left flank, and none of the other grout curtain holes in this area showed similar high grout takes.

The average grout take per sequence per stage is shown in Figure 10. Virtually tight rock mass conditions were encountered on the steep left flank across all stages. The results of water pressure tests gave low Lugeon values of generally less than 0,8 Lu with corresponding grout takes averaging 1,6 kg/m.- From the left bank grout take records, Block #29 (nearest to the observed high seepage zone) indicates a slightly higher comparative Lu to the adjacent blocks. However, under block #28, the foundation had low lugeon values.

Figure 10. Neckartal Dam: Average Lugeon and grout take per block during construction.

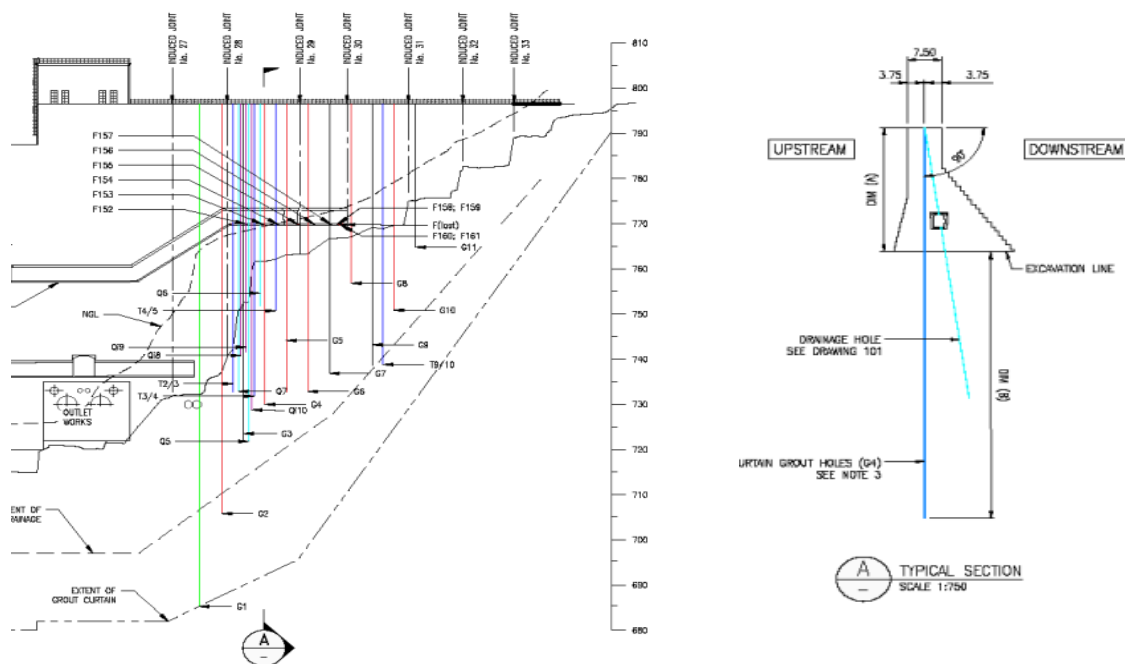
Figure 11. Drilling for grouting (red = primary, black = secondary, blue = tertiary, light blue = quaternary)

Drilling and grouting were conducted from the dam wall crest, and the grout holes are positioned so that the curtain is about 1 m upstream of the gallery and the original grout curtain. The grout holes, therefore, involve drilling significant lengths through concrete. Drilling was generally temporarily terminated when water losses were encountered to conduct water pressure tests and grouting, before continuing to the required depth. The location, direction, and depth of the actual boreholes are shown in Figure 11.

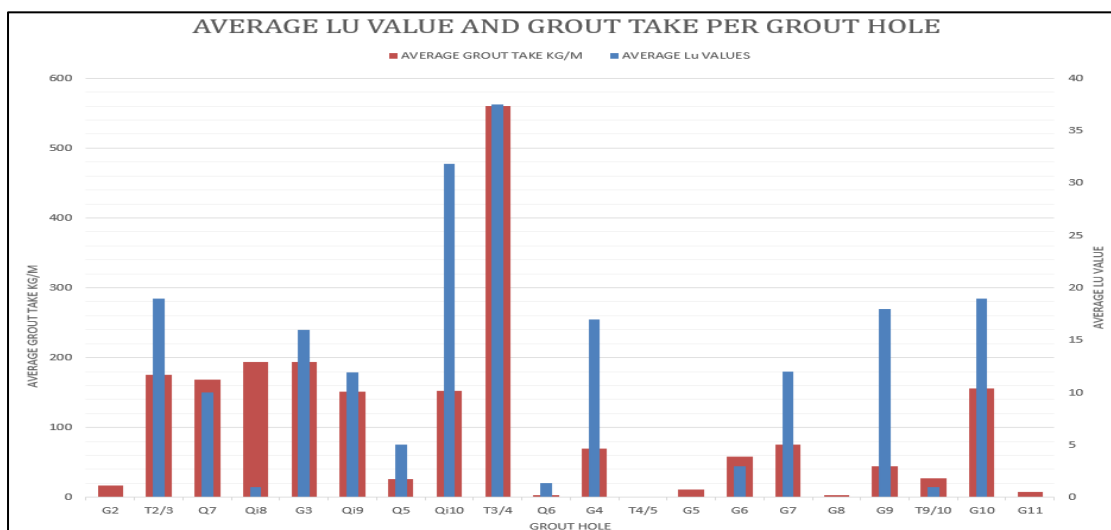
A distinct seepage zone with a moderate to high permeable area was observed from the depth of 25.0 m to the depth of 74.35 m into the rock mass between boreholes T2/3 to G4. The steep foundation interface between T2/3 and G4 can be assumed to be the contributing factor to the high rock mass permeabilities recorded. Moderate permeabilities and grout takes were recorded in the region higher up the left flank (from T4/5 to G11).

Figure 12. Average Lugeon value and grout take per hole.

A highly pervious zone was encountered at the steep slope foundation between T2/3 and G4, which recorded an average permeability of 15 Lugeon and an average cement consumption of 170 kg/m.

Low permeable rock mass conditions were encountered higher up the left flank at the gradually sloping and stepping foundation area, with an average Lugeon value of 5 recorded and a corresponding average grout cement consumption of 43 kg/m.

Different grout mixes are used based on grout take, adjusting thickness or allowing temporary setting before re-grouting. A summary of the average lugeon values and grout take per stage for the entire grouting is shown in Figure 12. It provides a summary of the average lugeon value per stage for each grout hole and the average grout take per stage for each grout hole, respectively.
