ASSESSMENT OF KARSTIFICATION DEGREE IN THE COPACABANA GROUP FOR A TAILINGS DAM FOUNDATION, SOUTH ANDES, PERU

This paper presents the assessment of the potential of karst dissolution in the Copacabana Group underlying about 50% the foundation of a proposed tailings dam and storage facility, located in the South Andes of Peru. A thorough geotechnical site investigation program was carried out in the area, which included regional and local geological mapping, geotechnical drilling, test pits, permeability tests, effervescence test in cores, petrographic analyses, and X-Ray diffraction tests. Hydrogeological studies, such as pumping and tracer tests, were also performed by other consultants to verify the observations, conclusions, and opinions developed from the geotechnical investigation program.

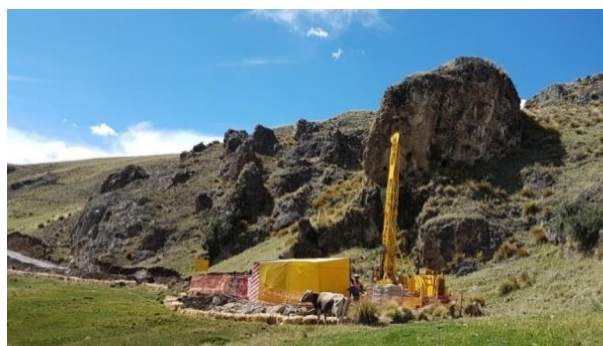
alternating with horizons of siltstones and dolostones. In two boreholes we identified two cavity zones (lengths between 0.6 and 1.45 m). The outcrop area is characterized by the presence of karst towers, defined as isolated, steep-sided limestone outcrops separated by topographically low areas, produced by the differential erosion, tectonism and dissolution of the limestones (Maslyn, 1977).

The karst towers are present downstream of the dam footprint, oriented along an E–W alignment, associated with steeply-dipping limestones (Figure 5). They are the result of the structurally controlled solution activity along discontinuities in the rock mass (bedding planes and joints provide access to water). Outside of the dam area, small caves and cavities (0.6 to 2.4 m in diameter) have been identified on the slopes above the area of well-developed karst towers. Collectively the karst towers and larger cave and cavities are representative of endokarst.

Figure 5. Photo looking NW. Karst towers in the lower member of the Copacabana Group, downstream of the dam footprint.

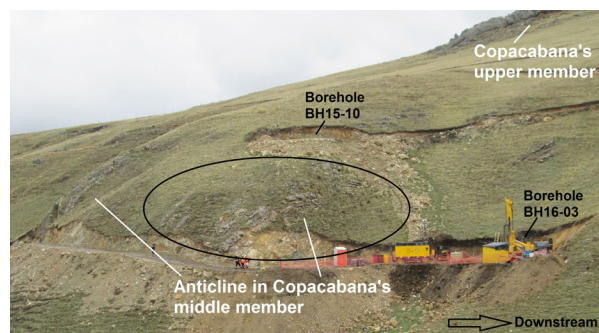
On the left abutment of the dam (looking downstream), an anticline is present with an E–W orientation that is transverse to the dam axis (Figure 6). This zone contains steeply-dipping and jointed rock, which is moderately to highly permeable and requires appropriate engineering treatment before the construction of the dam.

Figure 6. Photo looking NNW. Anticline in middle member at the dam area.

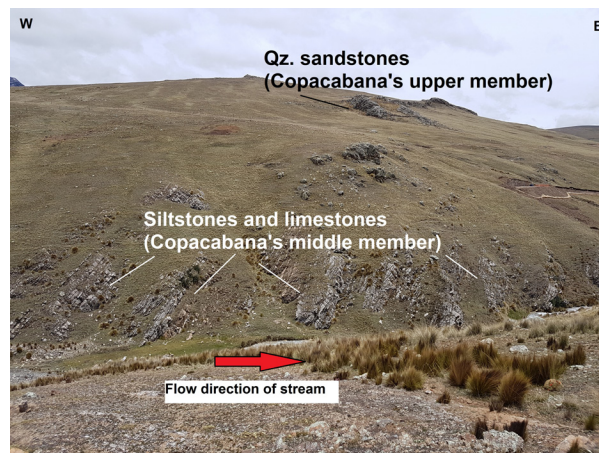
Figure 7. Bedding of the middle member at the impoundment area and quartz sandstone outcrop of the upper member at the top.

The bedding on the impoundment area strikes N–S and dips to the west (Figure 7). This condition is favorable for the watertightness of the TSF, considering that the flow direction of the valley is west to east, and permeability across bedding is lower than along bedding.

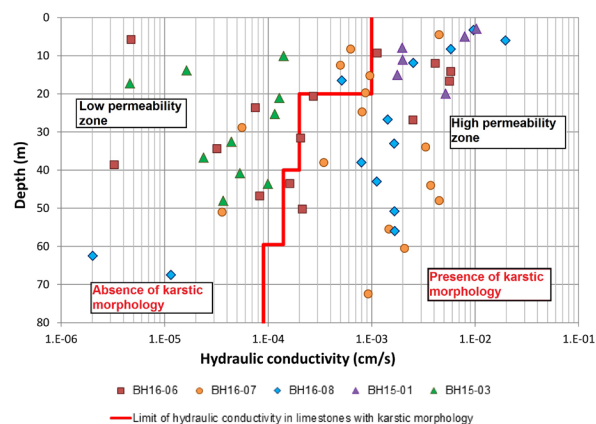
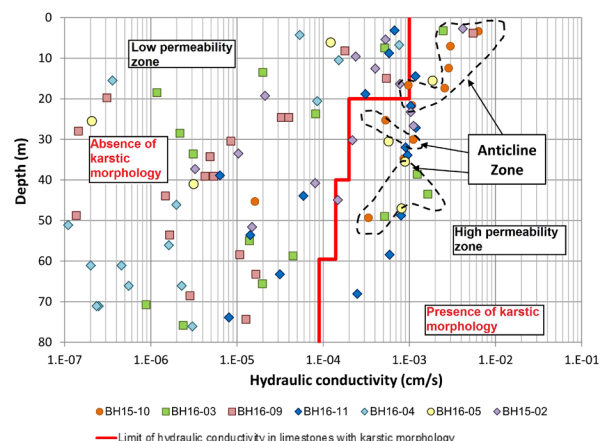
Figure 8 shows that the lower member mostly presents high permeability values, and this analysis indicates that is related to the development of karstic features.

Figure 9 shows the results of the middle member, which presents lower permeability values and therefore a less probability for developing karstic features, except for the results near the anticline zone, which presents high permeability due to the structural alteration of the zone and is related to the cavities found in some boreholes.

Figures 8 and 9. Hydraulic conductivity values from permeability tests in boreholes (BH 16-XX/BH 15-XX), lower member of the Copacabana Group (left) and the middle member (right). Limit of karstic morphology (red line) from D. Evans, 2015.
