The re-use of existing Bituminous Stabilised Materials for the rehabilitation of National Route 7 - Case Study

Synopsis – Western Cape Government’s (WCG) Department of Infrastructure recognised the need to rehabilitate the existing N7 (TR11/1) in Cape Town between the Bosmansdam Interchange (km 2.00) and the Melkbosstrand Interchange (km 18.02). WCG tasked the project team with developing a cost-effective, sustainable solution that would minimize disruptions to the traffic and local community during the rehabilitation of the N7. In response, an innovative approach to reprocess the existing bitumen stabilised material (BSM), which behaved somewhere between a published BSM and cement stabilised material, as well incorporating the milled off asphalt for use in the base layer was proposed. The proposal effectively meant re-processing the base material for a third time thereby providing a “third-life-cycle rehabilitation”.

This paper will focus on the materials investigation undertaken on the project that led to the design proposal, design process followed at the time, pavement life cycle evaluation and relook at the design post publication of the TG 2, 2020 BSM transfer function.

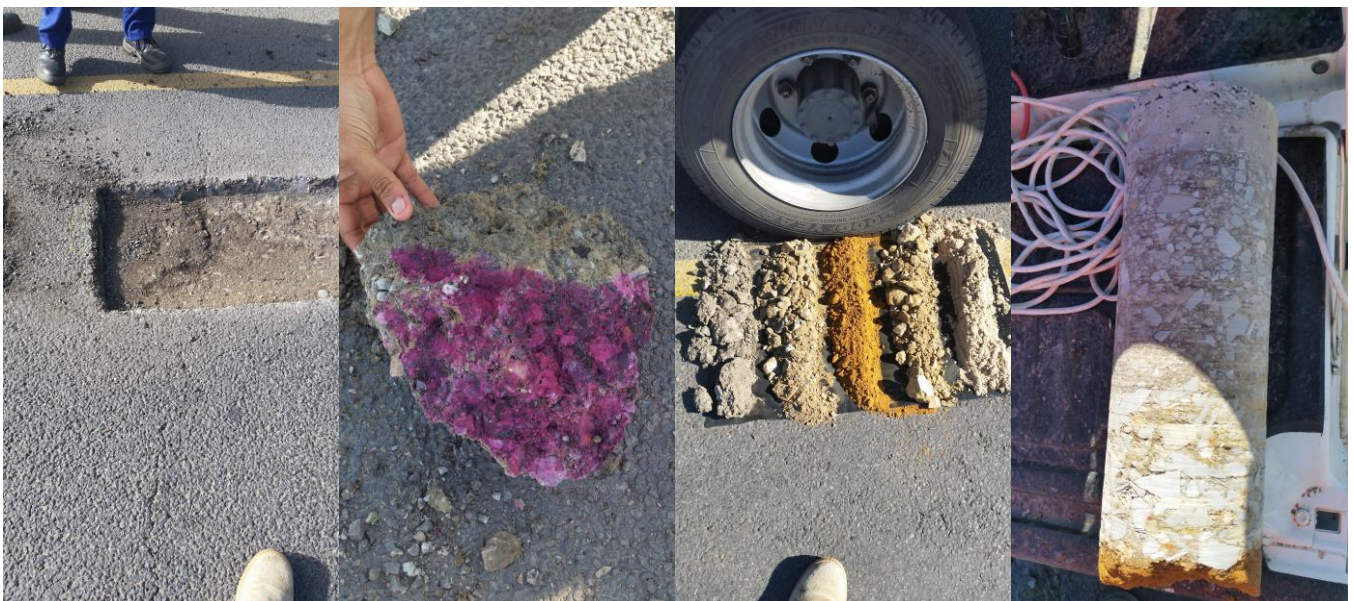
Early in the materials investigation and testing phase, it became evident that the existing base layer was not exhibiting typical BSM behaviour. Transverse cracks were observed as reflecting through the existing BSM base layer which exhibited high cement contents based on the phenolphthalein field test, as depicted in Fig. 2.

Fig. 2. Materials testing on the N7

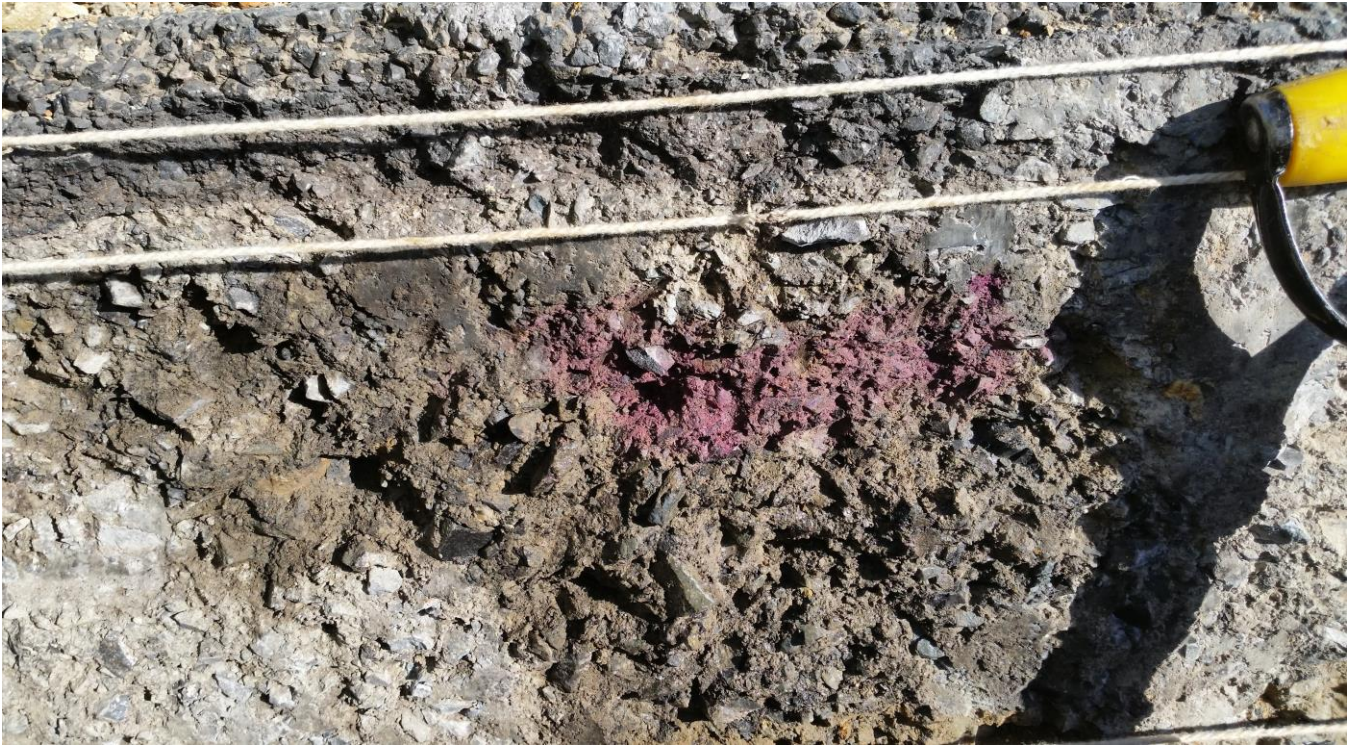
Trenches were excavated across the slow lane to assess the uniformity of the pavement layer depth and mixing consistency. Phenolphthalein sprayed across the face of the excavation revealed pockets of active cement in the base layer in certain areas. This indicated a significant amount of active cement still present in the BSM layer. This could be attributed to either excess cement (above 1.0 %) in the BSM layer or poor distribution of the cement within the BSM layer during construction. A typical example of this is depicted in Fig. 3.

Fig. 3. Typical example of active cement pockets within the BSM layer on the N7

The as-built materials records were interrogated to determine if additional cement, in excess of the design requirements of 1%, was in fact placed within the BSM layer. The as-built data records revealed a consistent cement content of 1.0 % and a foamed bitumen content of 2.3 % for the BSM foam sections. For the BSM emulsion sections a 1.0 % cement content and a 3.0 % bitumen emulsion content were recorded. The rehabilitation of the road was undertaken by means of in-situ recycling and it was concluded that the BSM may not have been mixed sufficiently at the time of construction resulting in pockets of active cement observed within the BSM layer. It was further concluded that the BSM layer was behaving somewhere between a flexible BSM and a stiffer cement treated material. This was evident in the variability in the defects observed on the roadway which included deformation (which is typical of a BSM material), to block cracking commonly associated with cement treated base materials.

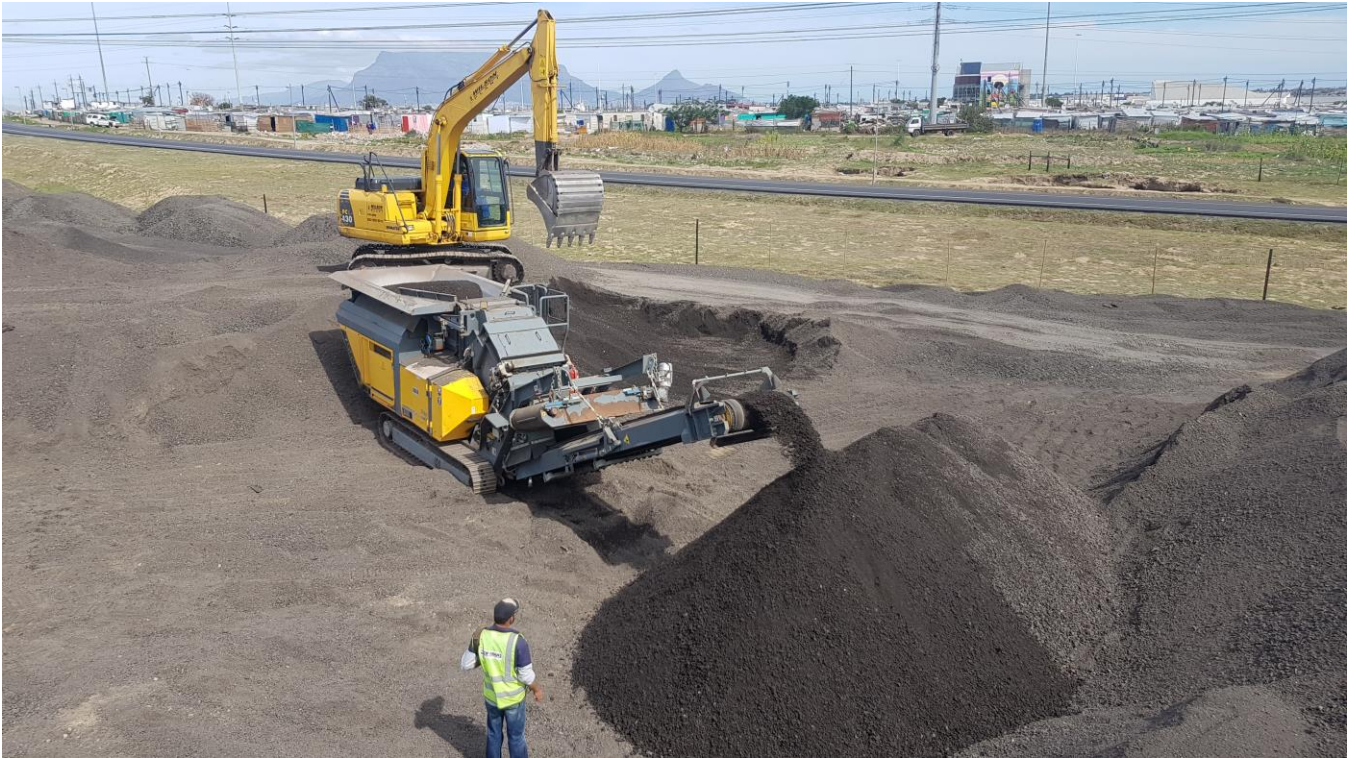
and tested to determine the mix design properties. RA was obtained from package 1 and stockpiled at the processing site where it was crushed and stockpiled.

Fig. 5. Crushing the RA at the Potsdam Interchange

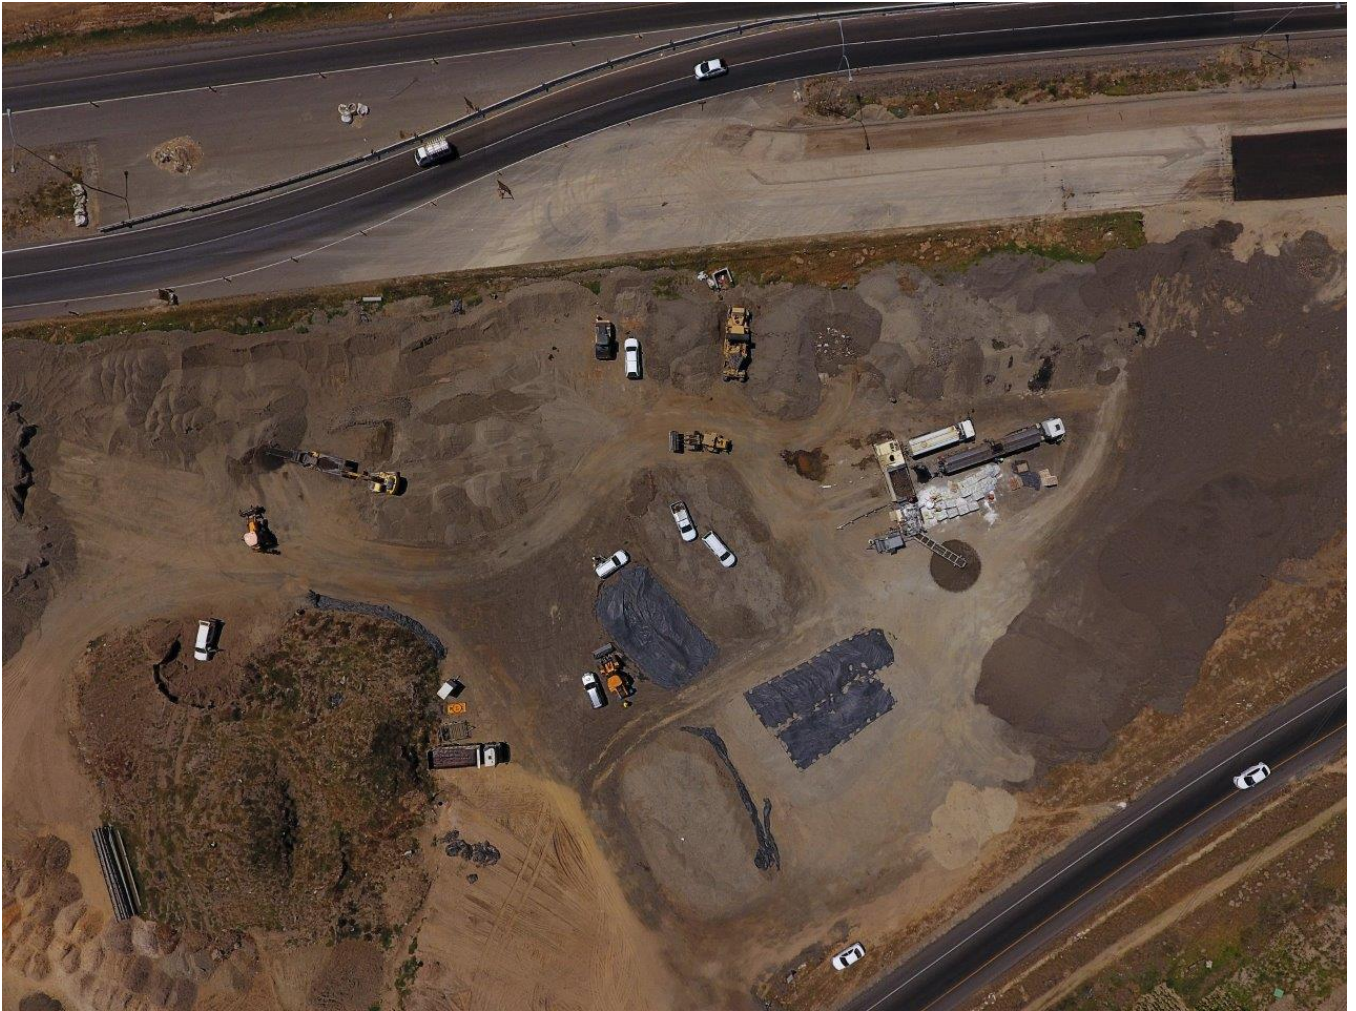
The South-West quadrant of the Potsdam Interchange was used as the stockpile and processing site as all three packages were carried out by the same contractor.

Fig. 6. Stockpile and BSM processing area at the Potsdam Interchange

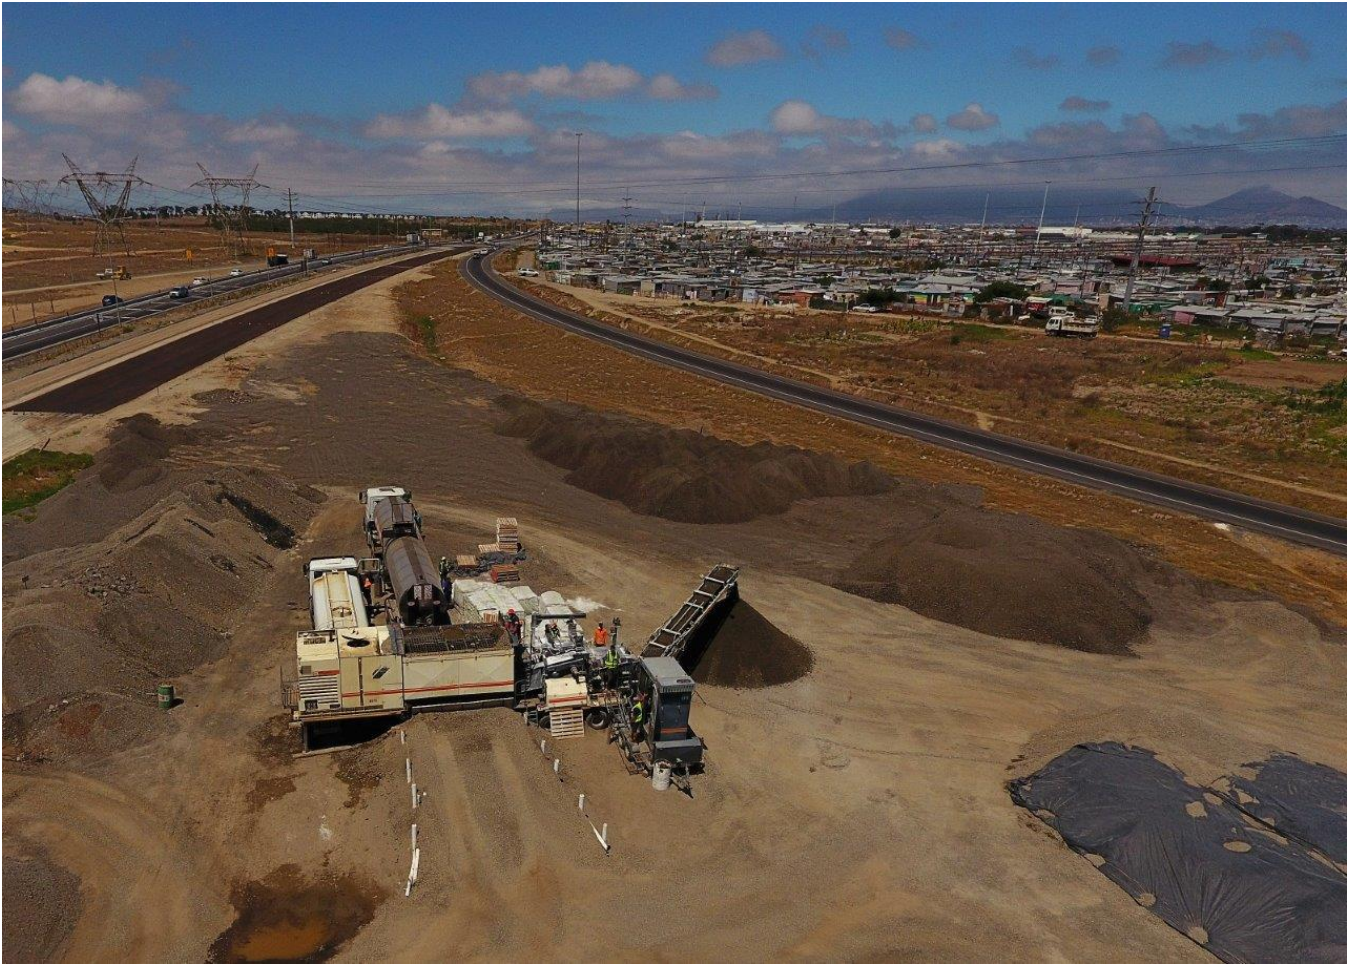
Work on the northbound slow lane commenced with the milling off of the asphalt surfacing and BSM in two separate operations and transporting the milled materials to the stockpile and processing site. During the trial mixing process, blending of the crusher dust and RA proved problematic mainly due to the poor mix consistency, aggregate segregation, excessive balling and binder stringers within the blend and it was agreed to proceed with 100 % RA in the mix for the upper BSM base layer. A more consistent mix was obtained using only the 100 % RA material. This was subsequently implemented for the trial section. The works commenced under long term closures limited to two days production in length so as to limit the effect of moisture damage to the opened road sections. This would also limit the length of closure thus reducing the impact on the traffic.

Fig. 7. BSM processing at the Potsdam Interchange

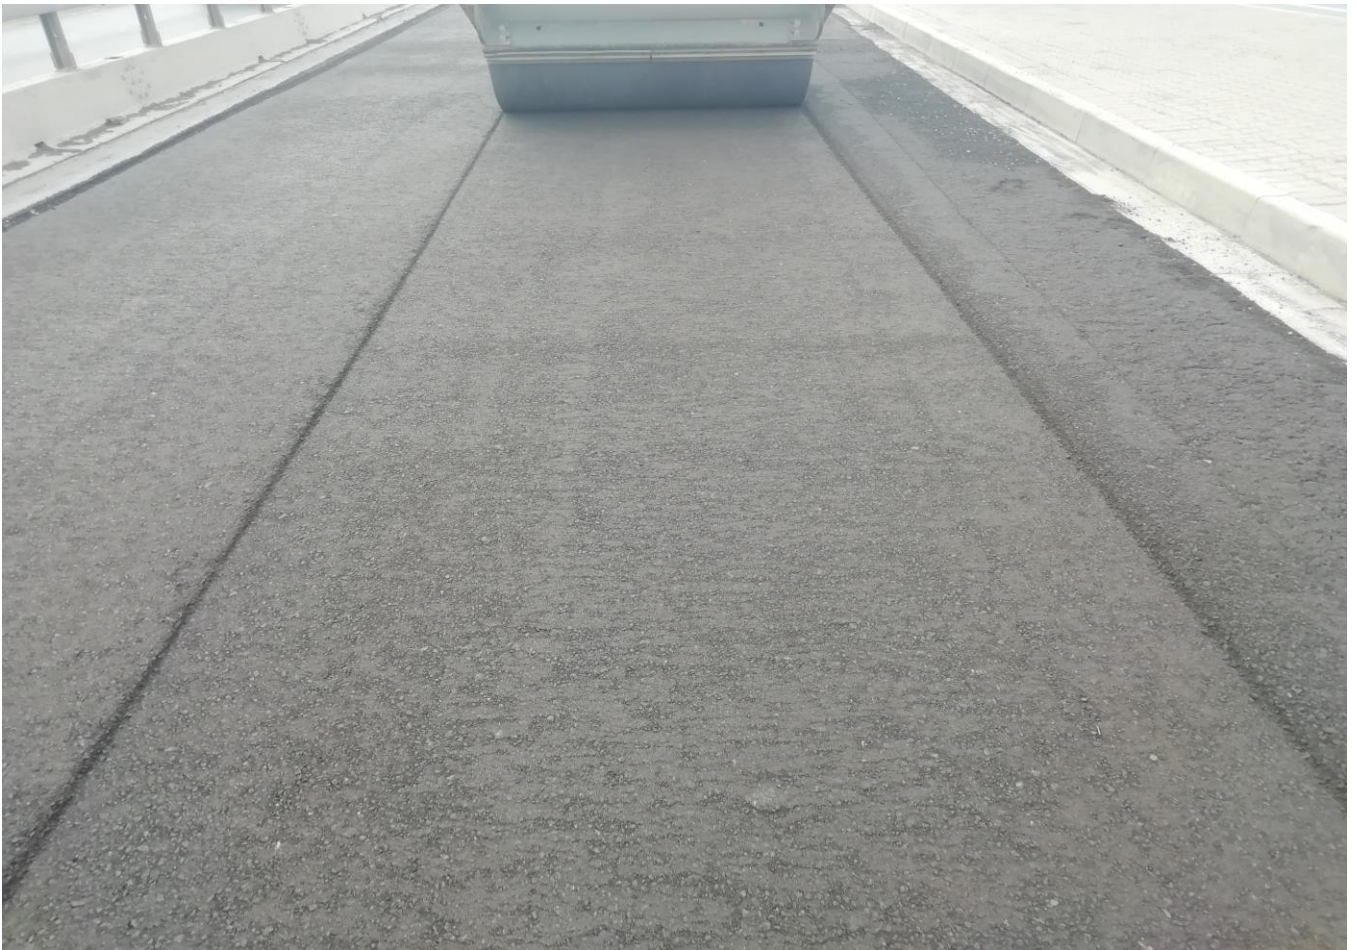
Fig. 8. 100 % RA BSM upper base layer

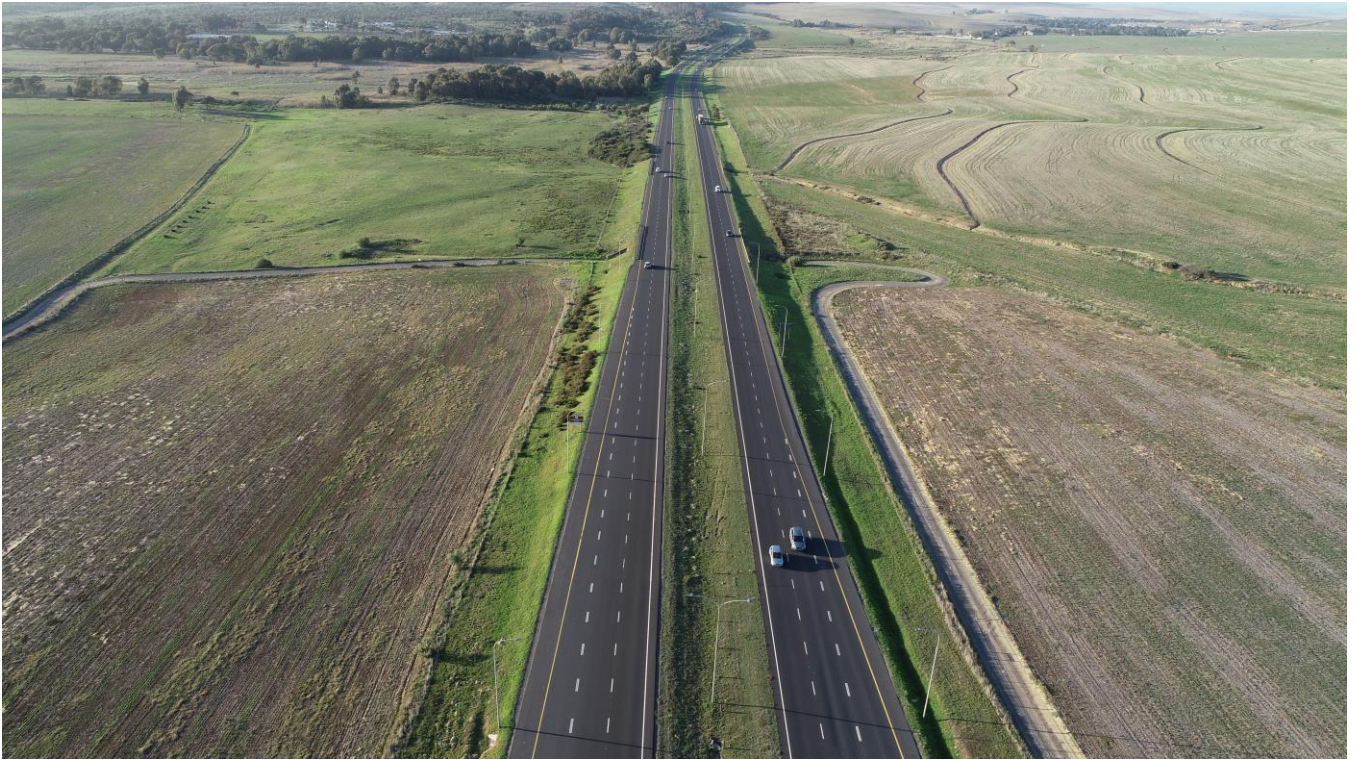
Fig. 9. N7 Complete

On completion of the BSM works, the top 20 mm of the BSM and the 20 mm temporary asphalt surfacing were milled off to ensure a smooth riding quality and better level control of the final asphalt surface. The milled BSM and asphalt were re-used on the weighbridge parking areas located alongside the project. All excess materials generated from Package 3 were used on the Package 2 project. Excess RA, generated from all three projects, was stockpiled for use on other Western Cape Governments projects identified in the area however, this valuable material resource was pilfered by local communities.
