Grouting to reduce seepage at Neckartal Dam, Namibia

R. Greyling, E. Lillie, D. Mouton

Knight Piésold Consulting, Pretoria, South Africa

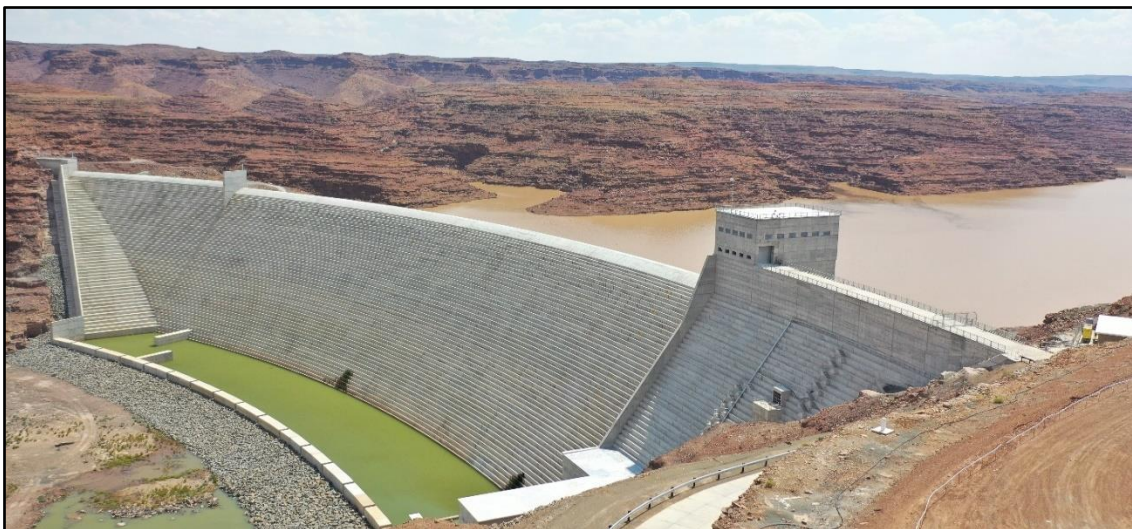
Figure 1. Neckartal Dam view from downstream.

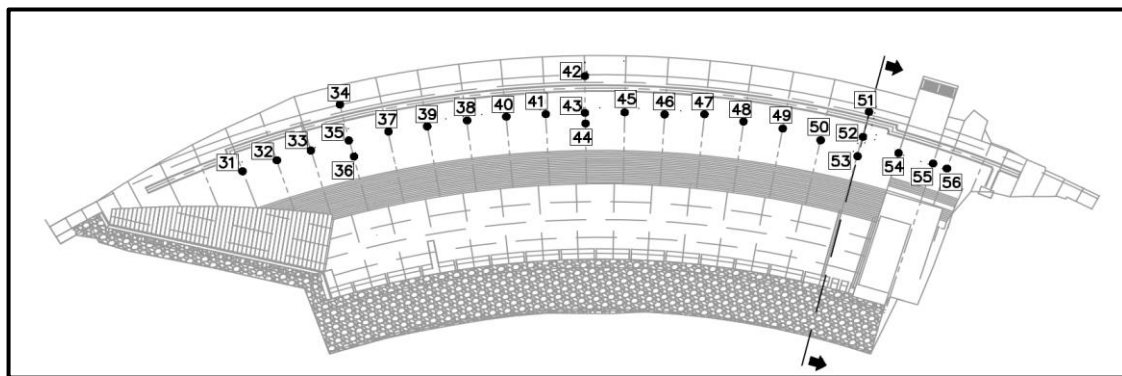
Figure 4. LBSGs at elevation 757 mASL – Location

The induced joint openings and temperatures are measured with #56 Long Based Strain Gauges (LBSG) installed mainly at two levels in the dam, viz at 730 mASL and at 757 mASL. The LBSG positions at elevation 757 mASL are shown in Figure 4.

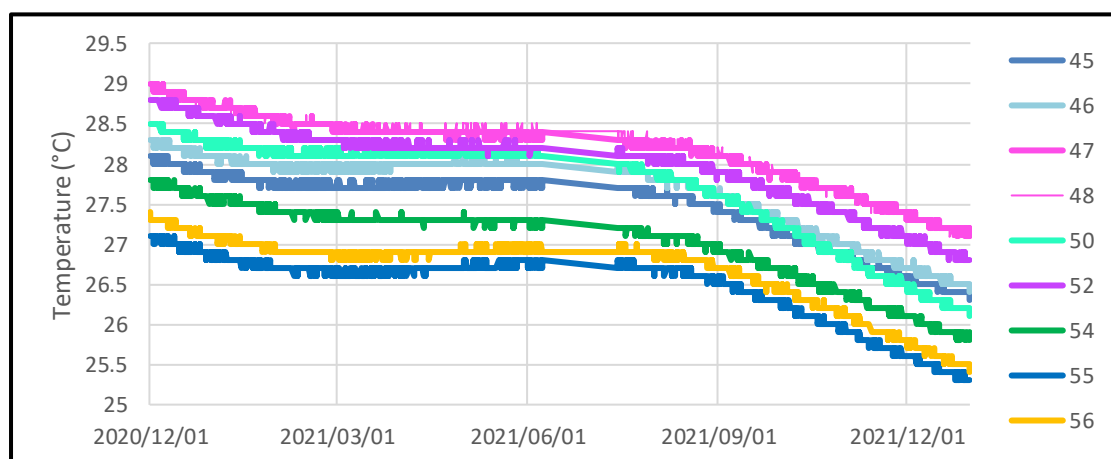
Figure 5. LBSGs at elevation 757m – Temperatures

From the LBSGs temperature records in the centre of the dam section and along the dam axis, the temperature has continuously decreased at a rate of about one degree a year. The average temperature of the dam core was approximately 30°C after placement in 2017. The current dam core temperature ranges from approximately 22 to 24°C in 2024, depending on the section thickness and foundation proximity. This has resulted in a six-to-eight-degree temperature decrease over seven years in the dam core. During 2021, the dam temperature decreased by almost two degrees after the rapid reservoir filling. The temperatures measured across joints # 18 to # 27 at the LBSGs #45 to #50, #52, #54, #55 and #56 are shown in Figure 5 below.

The LBSG indicated no opening or closing during 2021 except for joint 54, which opened by less than 0.1 mm during the first filling in January 2021. From the joints being monitored, no joint showed any significant movement, which could explain the seepage at VN008 increasing steadily between May and October 2021. The movements across joints #18 to #27 at LBSGs #45 to #50, #52, #54, #55 and #56 are shown in Figure 6 below.

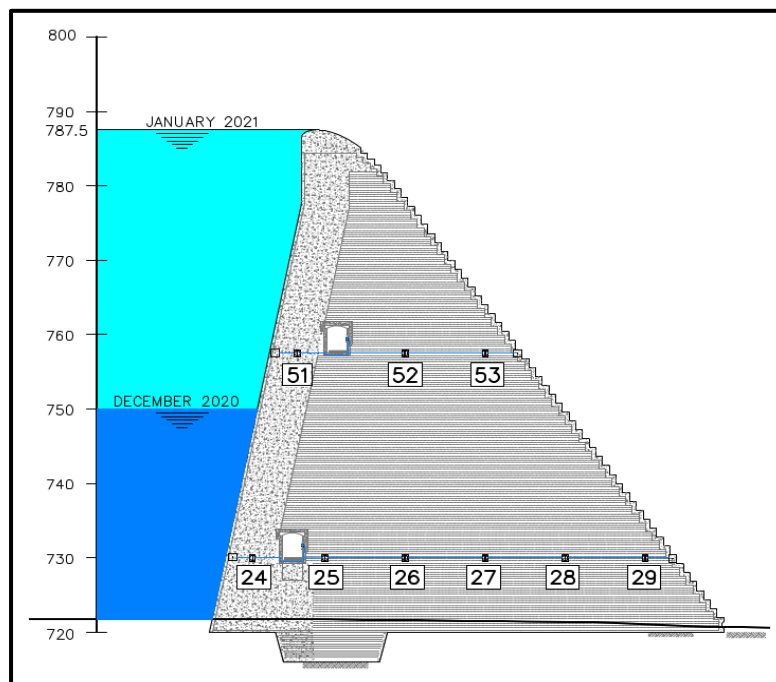
Figure 7. Dam Cross-Section Joint #24: LBSG on joint 24 at 730mASL & 757mASL

There are nine LBSGs in joint 24. Their positions are shown in Figure 7. The LBSG positions are at elevations 730 mASL and 757 mASL and are evenly spaced between the upstream and downstream faces of the dam.

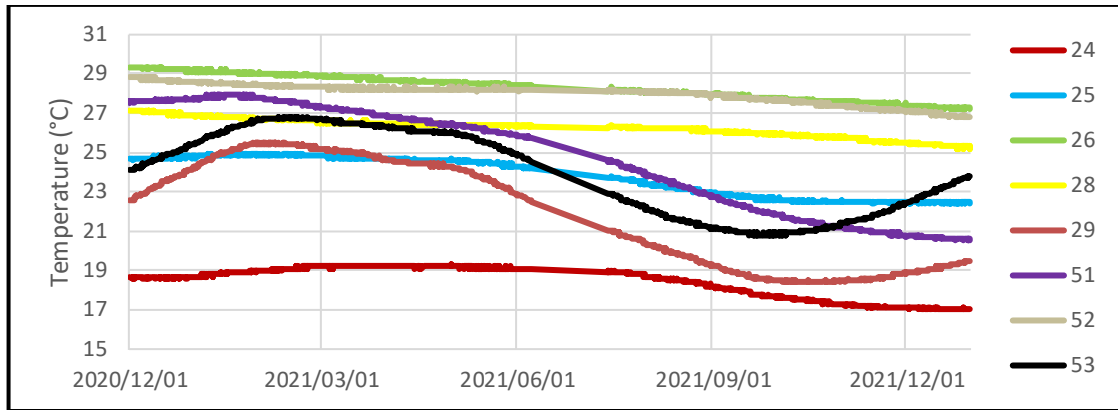
Figure 8. Neckartal Dam: LBSG across joint 24 at elevations 730mASL & 757mASL -Temperatures

LBSG #29 and #53 near the downstream face and LBSG 51 on the upstream face clearly show the impact of the ambient and water temperatures on the outer surface of the dam. LBSG #24 on the upstream face was already submerged in 20 m deep water from the previous year's wet season. The LBSGs closer to the dam core indicated a constant linear decrease over the whole year. The temperatures measured across joint #24 are at LBSGs #24 to #29 and #51 to #53 as shown in Figure 8.

The only two LBSG to show a significant movement during 2021 were the two gauges close to the dam's downstream face. LBSG #29 indicated an opening of approximately 0.3 mm, and LBSG #53 indicated an opening of approximately 0.15 mm. Thus, the only opening of joint #24 was on the dam's downstream face. Neckartal Dam is northwest-facing; therefore, the downstream face is exposed to significant warming from the sun. The movements across joint #24 at LBSGs #24 to #29 and #51 to #53 are shown in Figure 9 below.
