ASSESSMENT OF KARSTIFICATION DEGREE IN THE COPACABANA GROUP FOR A TAILINGS DAM FOUNDATION, SOUTH ANDES, PERU

This paper presents the assessment of the potential of karst dissolution in the Copacabana Group underlying about 50% the foundation of a proposed tailings dam and storage facility, located in the South Andes of Peru. A thorough geotechnical site investigation program was carried out in the area, which included regional and local geological mapping, geotechnical drilling, test pits, permeability tests, effervescence test in cores, petrographic analyses, and X-Ray diffraction tests. Hydrogeological studies, such as pumping and tracer tests, were also performed by other consultants to verify the observations, conclusions, and opinions developed from the geotechnical investigation program.

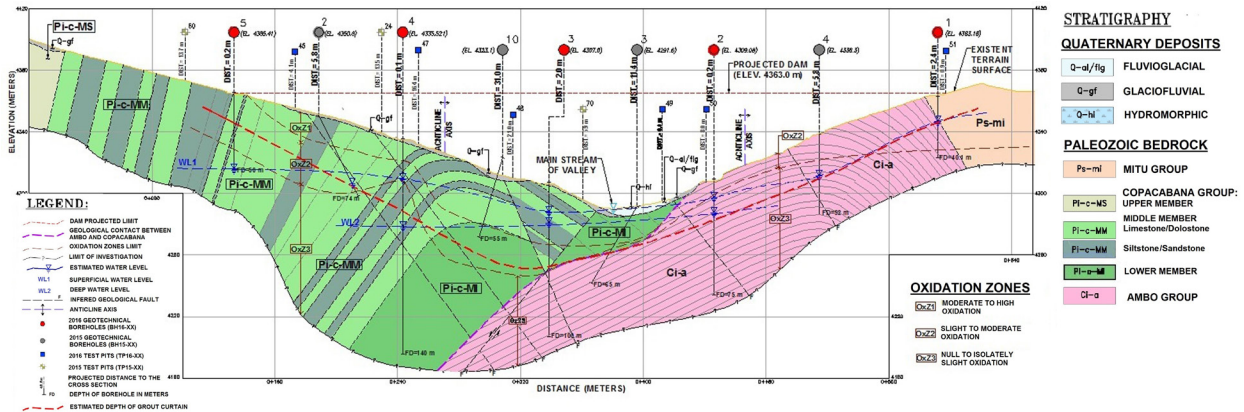
Figure 3. Geological cross section A-A' along the dam axis (looking downstream).

The fault system underlying the valley floor and the northwest to north-striking faults cutting the Copacabana Group on the north valley slope faults likely provide some control of karstification near the dam site and may separate an area of relatively severe karstification downstream of the dam site from less severe solution activity in the impoundment area.
