Challenges with conducting tailings dam breach assessments

Violeta Martin^a, Anna Akkerman^b

Power and Water Resources, Knight Piésold Ltd., Vancouver, BC, Canada

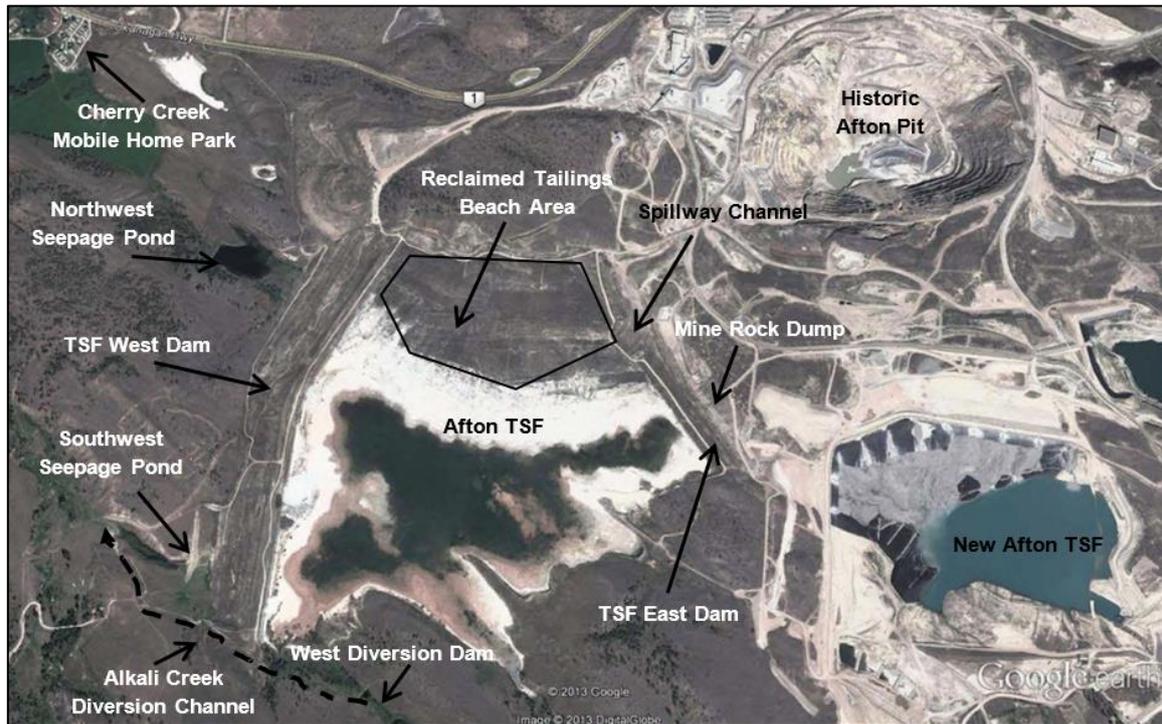
Figure 1. General arrangement of the Afton TSF

The Afton TSF incorporates two two-zoned earthfill/rockfill dams with engineered filter zones, riprap lined spillway, two seepage collection ponds, and upstream diversion structures sized for a 1 in 200 year peak flow event (Figure 1). The Afton Mine ceased operations before reaching the full mine life and the dams were never raised to their ultimate design height; however, the dams were constructed to their

ultimate design width. Consequently, the East and West Dams were overbuilt for conditions when operations ceased, and the crests of the dams were left at approximately 100 m wide. A portion of the East Dam was buttressed by a waste rock dump that is higher than the East Dam itself, while the West Dam was constructed with relatively shallow downstream slopes (shallower than 2H:1V). The spillway is designed to pass the PMF and has an invert constructed 2 m below the crest of the East Dam. The spillway consists of a 50 m wide riprap lined channel (Figure 2) that transitions to an unlined earth channel, which curves along the toe of the East Dam and leads to a haul road located along the perimeter of the Historic Afton Open Pit. The sand tailings beaches have been capped and revegetated, and the TSF pond is mostly dry (Figures 1 and 3).

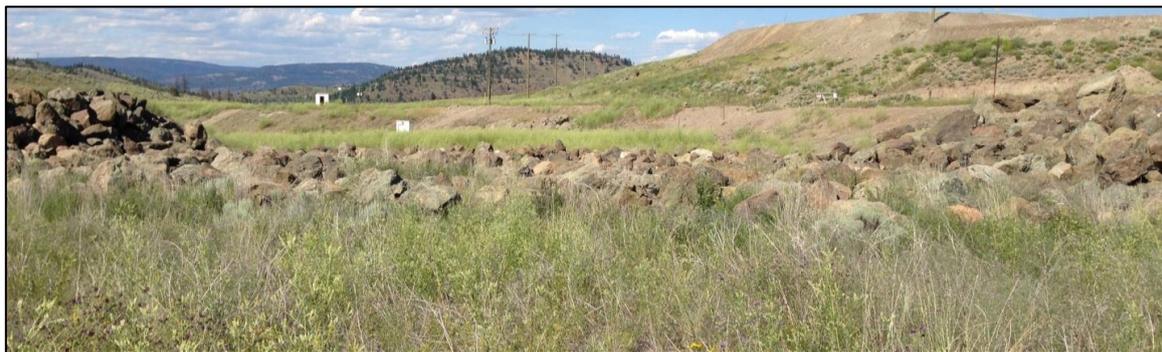
Figure 2. Riprap lined spillway entrance with reclaimed tailings beach in the foreground and waste rock dump on the right side of the frame; looking downstream (northeast)

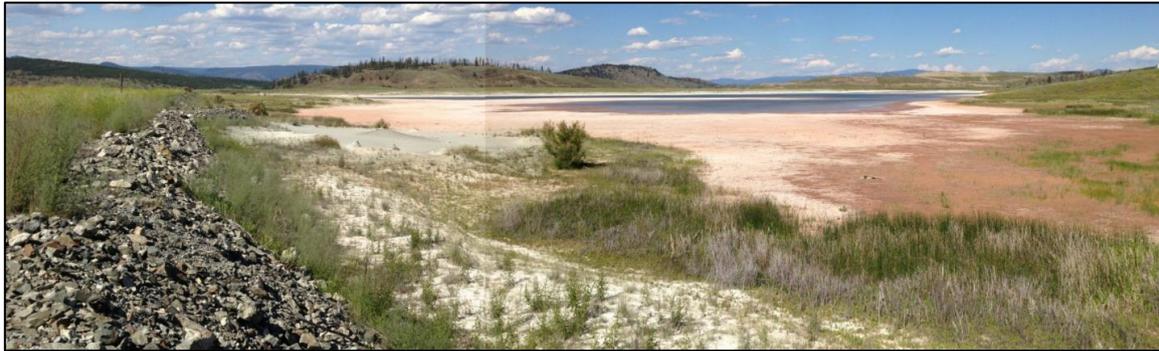
Figure 3. TSF pond on July 9, 2013; looking northeast
